Summary of events

Grampian Guardian / Golden-eye Location

Marine Safety Forum

28th May 2009

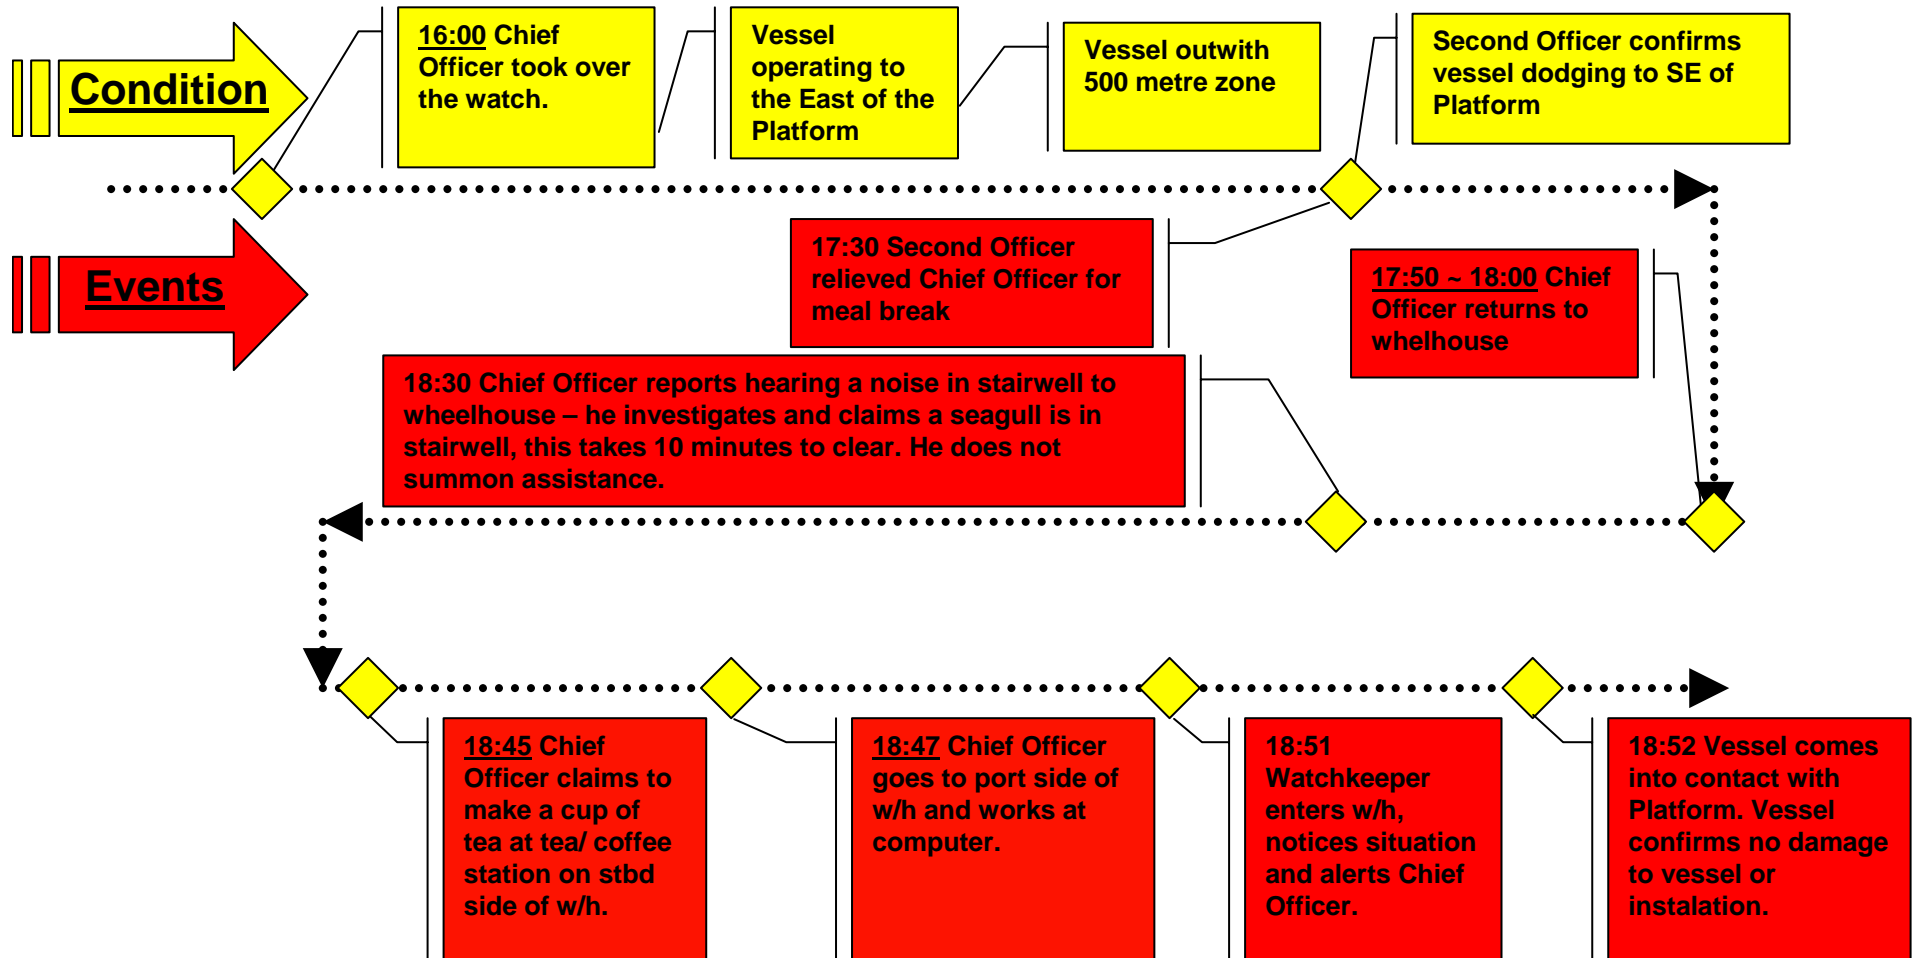
Time-line of events

- **Vessel struck platform.**
- **Vessel had propulsion and power through-out.**
- **Vessel was dodging on main engines to the East of the Platform.**
- **Vessel was in a drift OFF situation.**
- **Vessel was dodging outwith 500 metre zone.**
- **No faults were noted with any machinery or control systems.**
- **The Chief Officer was on watch, his watchman was undertaking other duties as instructed by Chief Officer.**
- **The Chief Officer was experienced, and held a Master Mariners Foreign Going CoC.**
- **The Chief Officer was on the bridge computer in the Radio Room composing an email. The PC records show a draft email was saved at the time of collision (18:52).**
- **The Chief Officer has resigned after admitting he was not keeping a proper lookout.**

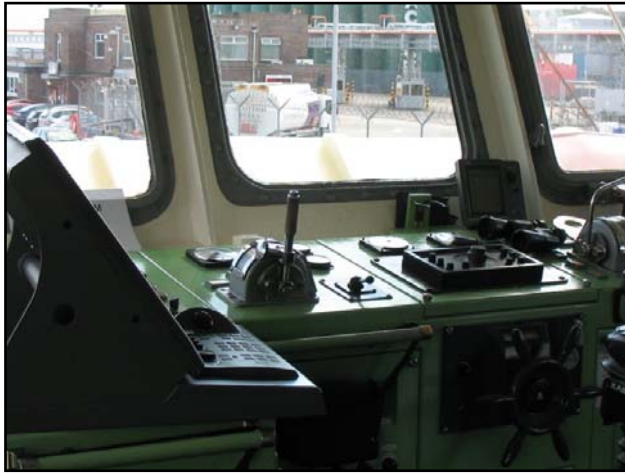
**Wheelhouse and forward
starboard visibility**

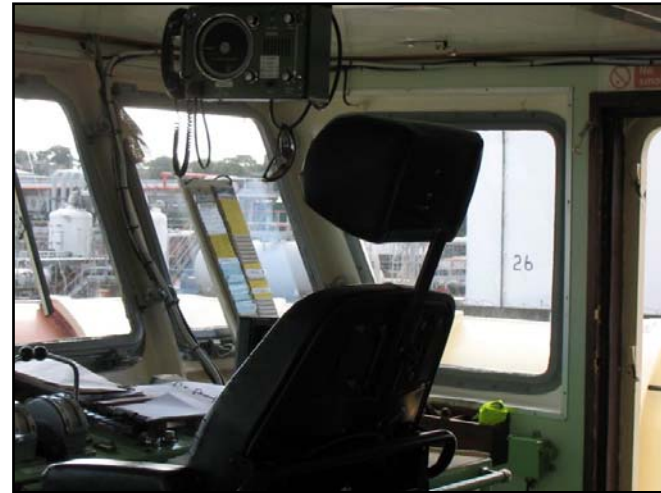
**Wheelhouse and
forward visibility**

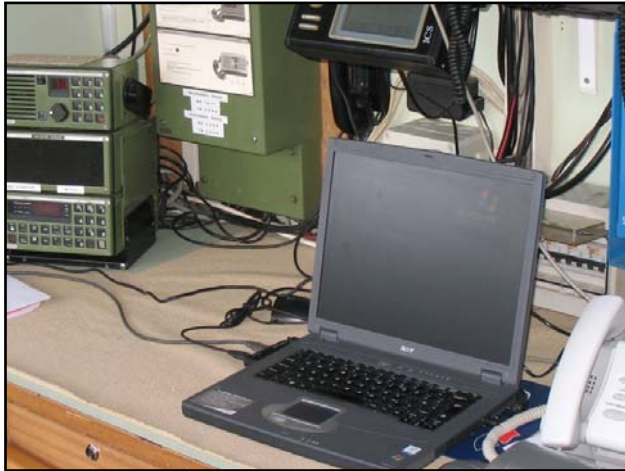
**Computer and Radio
Station – Port side.**

- The Chief Officer failed to keep a Safe Navigational Watch, in particular he failed in his duty to maintain a lookout.
- The use of the computer by the Chief Officer, in a location not offering good visibility was a major factor in this incident.
- The Chief Officers claims of having been distracted by a seagull have no bearing in this incident. It is difficult to believe the claim, no witnesses noted the seagull and the claim was made some time after he admitted to the Master he was working at the computer.

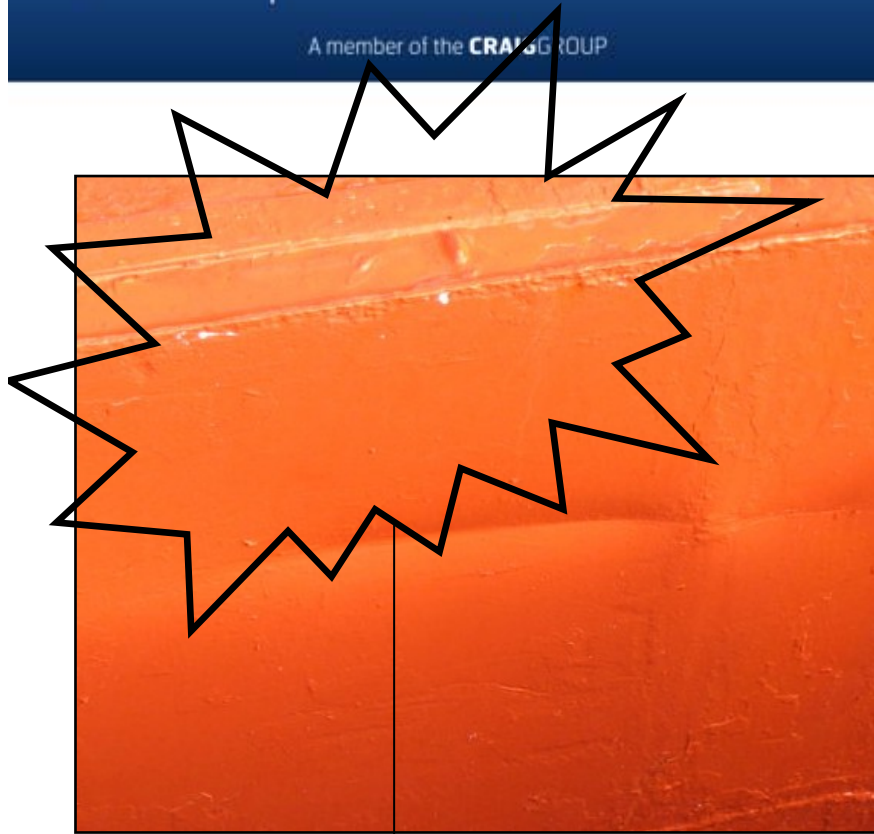
Area of contact with Platform

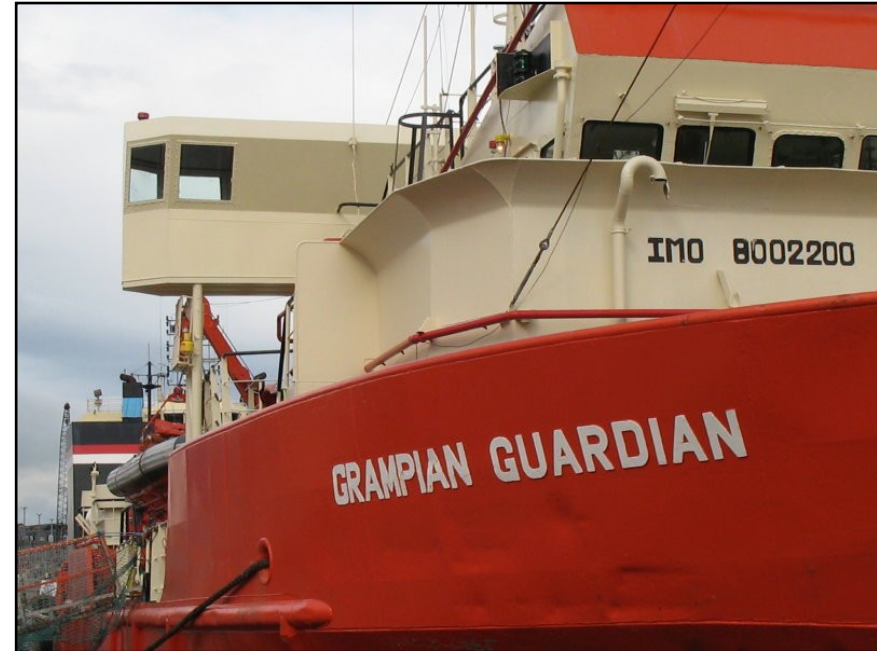
Grampian Guardian – Starboard Bow
