Marine Safety Forum – Safety Flash 09/06

Subject: Cargo Securing

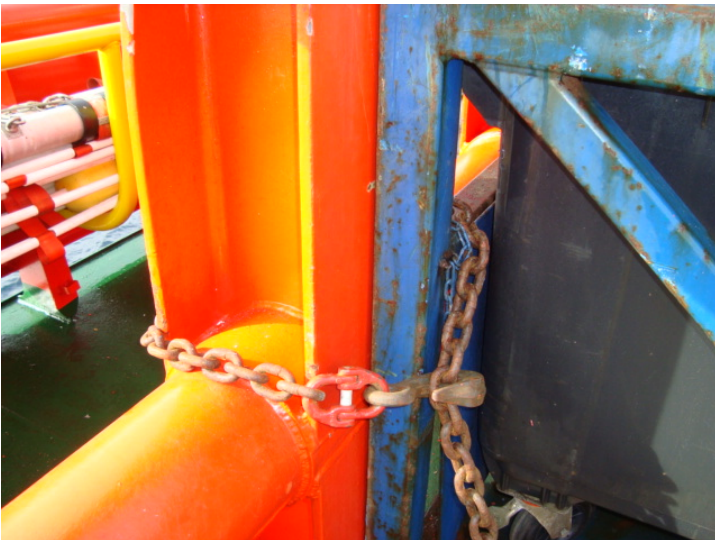
A recent near miss was recorded on one of our vessels where the chain sling was fixed to the cargo rail through the garbage rack structure. When the other end was slacked down the crane driver lifted the unit and the chain became tensioned to breaking point. Nobody was injured. The securing chains should **NEVER** be lead through the cargo being secured as this requires the deck crew to slacken down both sides and may not be possible on a tightly stowed cargo deck.

INCORRECT LASHING

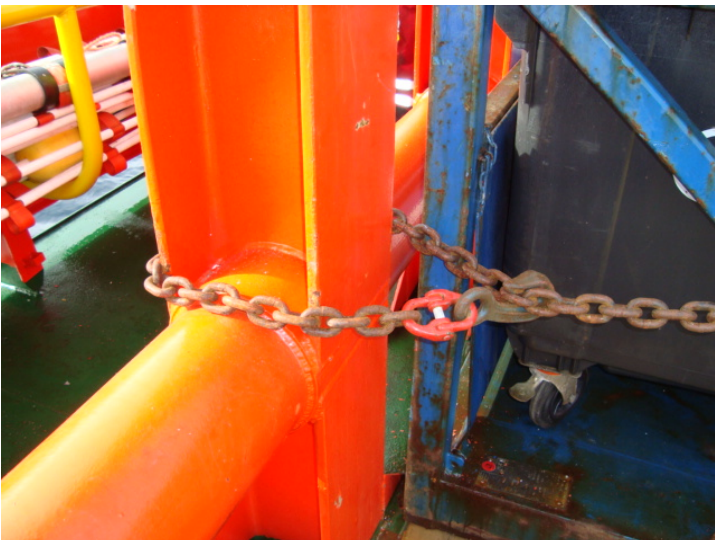
CORRECT LASHING
