# Marine Safety Forum – Safety Flash 08-21

## Subject: Serious Accident to Second Engineer

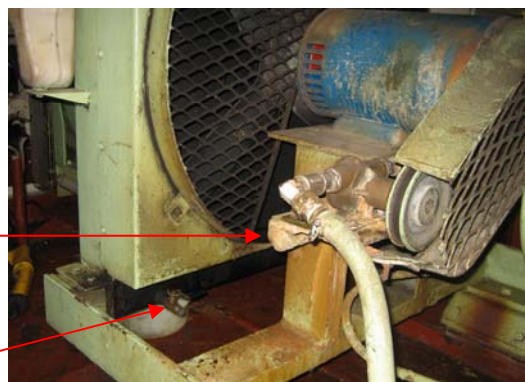
A Second Engineer was taking a water sample from the air cooler radiator of an air compressor. He was closing the drain sample point using a spanner held in his left hand and had his right hand on the cooling fan guard at a point where there was a gap in the guard. At that moment the compressor started on auto start. Unfortunately he lost the 3 middle fingers of his right hand.

- The guard was not complete around the cooling fan as a small segment had been left for maintenance purposes. This does not appear to have been recognised as a hazard before this accident. Ships management and external inspectors should ensure a critical look is taken at work places during area inspections to identify such hazards.

- The sample drain under the radiator pointed towards the compressor when it could easily have been turned 180 degrees so it could be accessed from a safer position in front of the radiator.

Unguarded section  
of fan

Water sample  
drain point

- The isolation of this compressor was not consistently done when water samples were taken on a routine basis. There was no risk assessment or job card to highlight isolation during water sampling.

- It might also be considered that isolating machinery in such a case should be standard engineering practice.
- Chief Engineers should satisfy themselves that the correct level of supervision is in place for all tasks in machinery spaces.

- Routine tasks should receive proper care and attention. Where formal risk assessments are not considered necessary it may be prudent to develop work routines or job cards which state the controls which are required. The Step Change in Safety “Task Risk Assessment Guide” contains useful advice on this.
