## Marine Safety Forum – Safety Flash 08-16

Issued: 10<sup>th</sup> March 2008

Subject: LTI During Backloading Operations

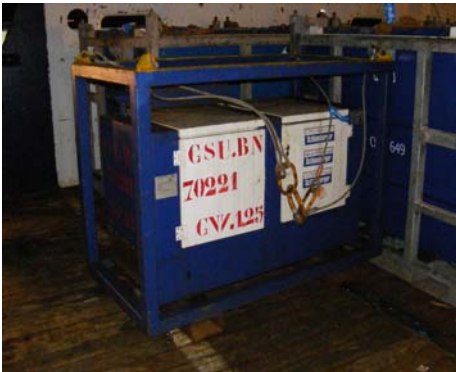
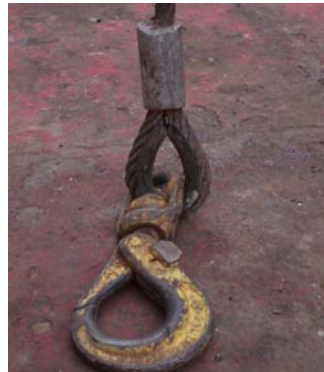
A Lost Time Incident occurred on a North Sea platform supply vessel where an open frame with a generator inside was backloaded and landed on deck. Once landed, the crane driver lowered his whipline and pennant to allow the deck crew to detach the hook. The hook and lifting bridle of the frame had fallen inside the frame and the deck crew decided to release the hook from this position. One seaman then held the pennant and gave a hand signal to the crane driver to hoist his line. As he did so, a ferrule clamp on the wire caught on the frame causing it to lift momentarily and then fall down on the seaman's foot. The incident resulted in two broken metatarsals to the left foot of the injured party.

As a result of the above incident involving the ferrule of the crane pennant becoming snagged on an item of cargo being backloaded, this is a reminder of MSF Safety Flash 06-15 regarding types of ferrule terminations to be used on crane pennants.

- Not to guide a crane hook out of framed units if it is caught inside
- Open top-type lifts to have either a grating or tarpaulin cover attached to prevent lifting sling from falling into lift
- Attention should be paid to the type of ferrule in use

The original incident in April 2006 resulted in a hand injury caused by the protruding ends of wire from a standard ferrule termination. **The recommendation made was to utilise crane pennants for offloading / backloading supply vessels which are fitted with a Flemish or 'super loop' type of termination.** As well as reducing the likelihood of injury this type of termination, which has a tapered top encompassing the wire ends, will also reduce the possibility of snagging on cargo.
