Marine Safety Forum – Safety Flash 08-30

Issued: 21 August 2008

Subject: Defective Blocks on Main Mast

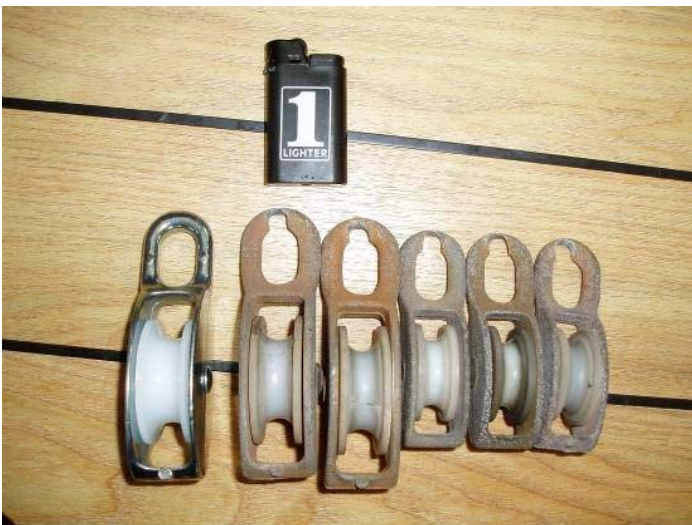
As it can be seen from the photograph below, the lugs on each of the 5 blocks for the flag halyards were almost completely sawn through and it was almost inevitable that, if unchecked, at least one of the blocks would have parted within a short period of time.

The effect of these blocks falling from their location on the main mast, as indicated on the following photograph, would have resulted in very serious implications to any personnel below.

To reduce the risk of injury to personnel it is recommended that the blocks fitted to the main mast for the flag halyards are given a thorough visual check on a 6 monthly basis and that any defective or worn blocks are replaced as necessary. In addition it is recommended that this task should be included within a vessel's planned maintenance system.
