# Safety Alert

**Number: 18-06**

**Subject: Self-Closing Valve Ruptures Mud Hose**

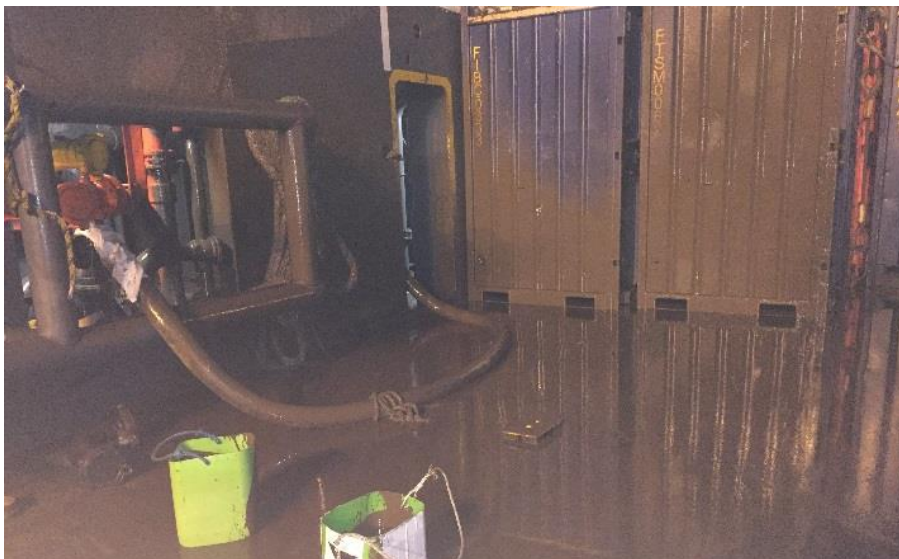
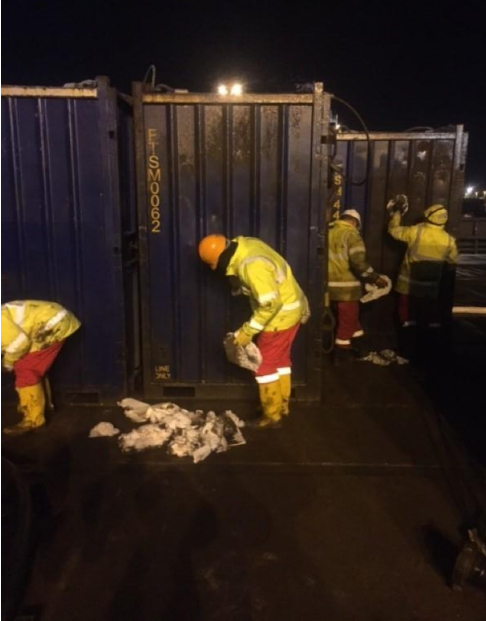
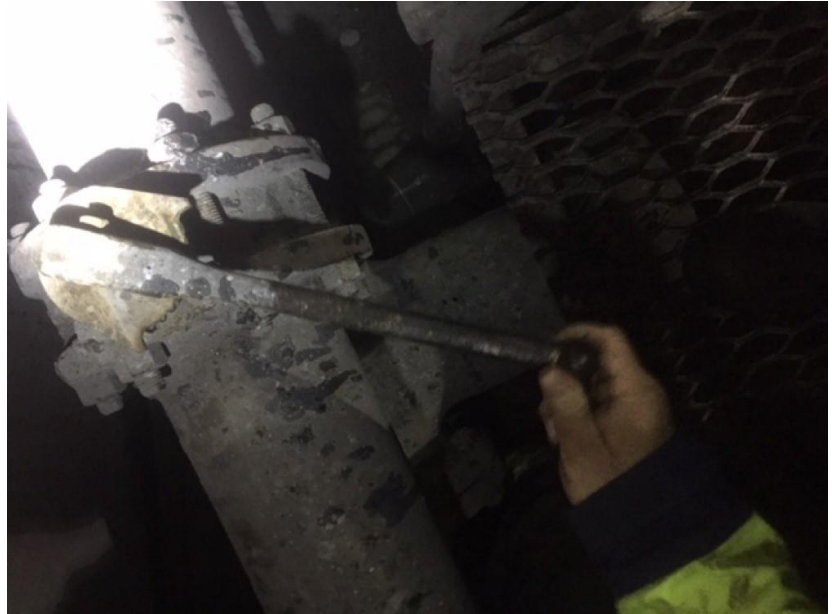
## Photographs / Supporting Information

An investigation was carried out by Ship Staff with the assistance of the Cargo Surveyor who discovered that the shore side loading valve at the connection to the receiving tank was in very poor condition. The thrust plate was severely worn and provided no friction to hold the valve in the 'Open' position. It was concluded that the valve self-closed during the operation which caused the pressure in the hose to rise and exceed the working limit.

The incident was reported to the base operators and third parties involved. This should encourage a review of their procedures and preventative maintenance. Please ensure this issue is raised and discussed during your next toolbox talk with Cargo Surveyors prior to bulk cargo operations in port.
