Safety Alert

Number: **19-05**

Subject: **Safe Mooring**

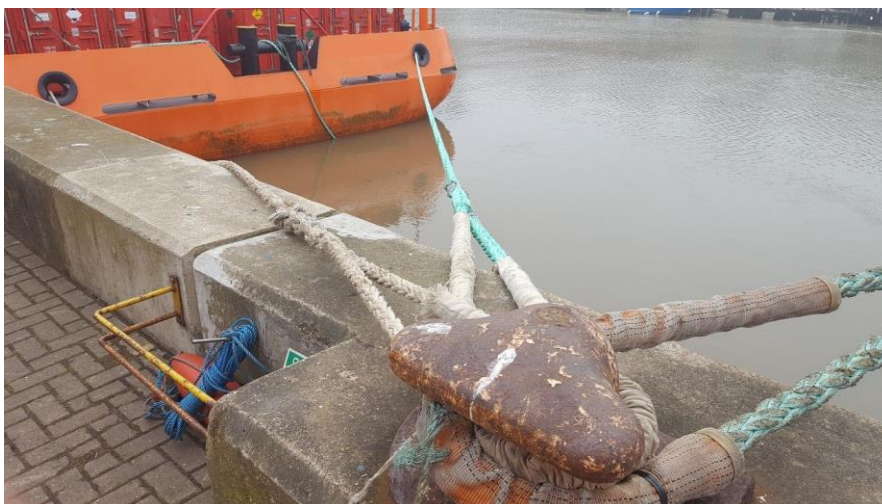
Photographs / Supporting Information

During routine mooring operations, a vessel was letting go aft. The stern line was slackened off the bitts and linesman on the quayside threw the tail end of the rope into the water. Due to a strong wind and ebb tide, the rope end was carried under the vessels stern and became fouled. A diver was subsequently contracted to remove the line with no damage caused.

- Communication should have been established with the linesman before the vessel commences mooring operations. When letting go, linesman should be requested to walk slack lines along the quayside so that the deck crew can heave the rope in.
- Where possible efforts should be made to avoid mooring ropes touching the surface of the water however it is recognised that due to vessel type/design this is not always possible; in these cases efforts must be made to control the amount of rope in the water to minimise the risk of ropes getting drawn into propulsion.

Please review all ship specific mooring risk assessments onboard, considering the following factors:

- A toolbox talk should be conducted prior to mooring operations. During the discussion the current and predicted tidal streams should be discussed. The Chief officer should clearly instruct the crew which lines are to be made fast/let go and in which order. All deck crew should be clear on their role in the operation.
- Junior crew should receive training on correct rope handling techniques. These crew should be rotated between the fwd. and aft mooring stations to familiarise themselves accordingly.
- Hydraulic machinery such as capstans and windlasses are there to assist the crew in mooring operations. **All** personnel should be familiar in their use.
- 1m messenger lines should be spliced to the tail ends of mooring ropes, for use by the harbour's linesman. (Please note this may vary from harbour to harbour – ensure you are aware of each harbour requirements)
