Safety Alert

Number: 19-08

Subject: Near Miss – Dropped Object

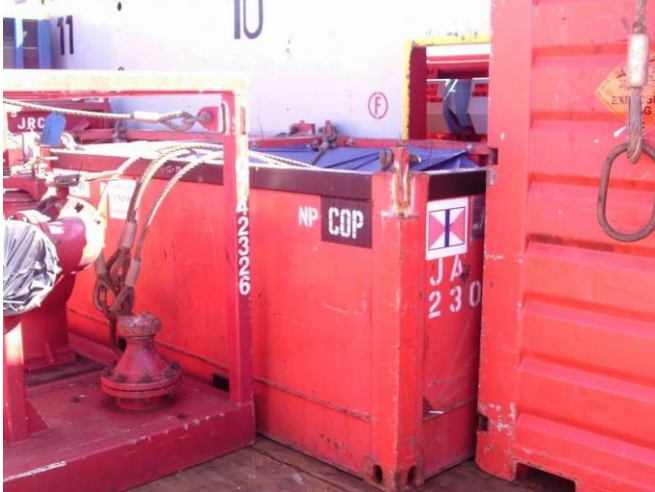
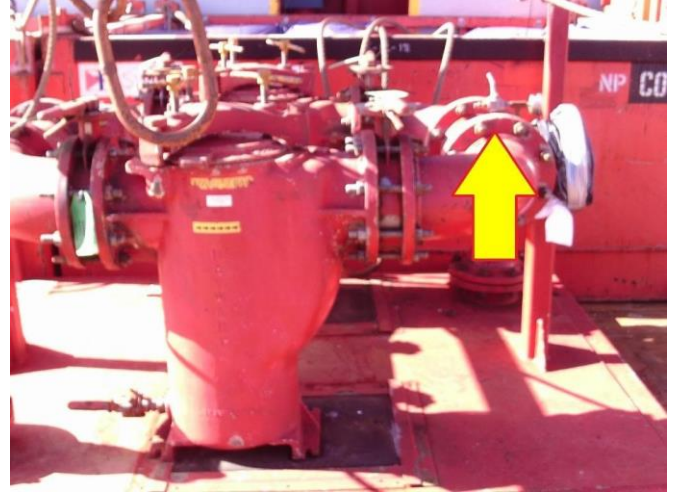
First Event

Vessel engaged in offshore backloading operations at North Sea installation. The Crane Op attempted to backload a manifold and pipework arrangement within a transport frame. The lift came into contact with an adjacent lift on the vessel and caused a pressure gauge to break off and fall to the deck below. It is unclear if the gauge (approx. 3kg) contacted the adjacent lift or if the sling was momentarily slackened during contact and snagging the gauge when taught. Both causes could have been eliminated had the lift been appropriately secured and protected prior to transport and in accordance with GOMO guidelines for unusual cargo items.

We can only observe that some of the industry safety barriers such as pre-transfer checks may have been missed by the installation crew resulting in the dropped objects. Additionally, the lifting arrangement for the manifold and pipework did not offer suitable protection on the sides or top of the lift to prevent such events occurring.

The vessel measures in protecting crew from potential dropped objects were well executed by ship staff. The deck crew were wearing appropriate PPE and correctly standing in a safe place while the load was suspended over the deck. These reports highlight the importance of these basic control measures aiming to protect the crew involved.

The Safe removal of potential dropped objects from a lift once identified requires good collaboration between the deck crew and the Crane Op. All persons involved are reminded of the Stop the Job Policy and their authority to use it when required. This report has been shared with the charterers and other stakeholders for their info and sharing of lessons learned.

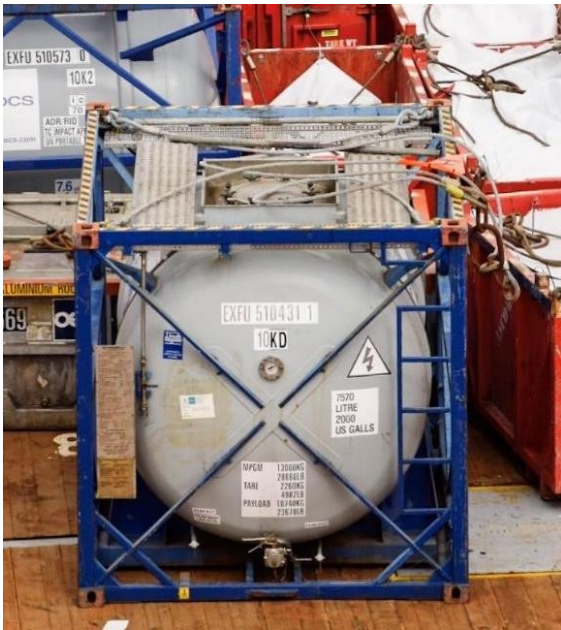
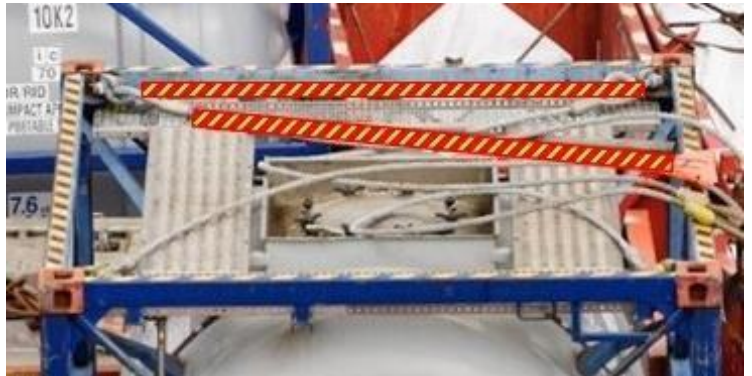
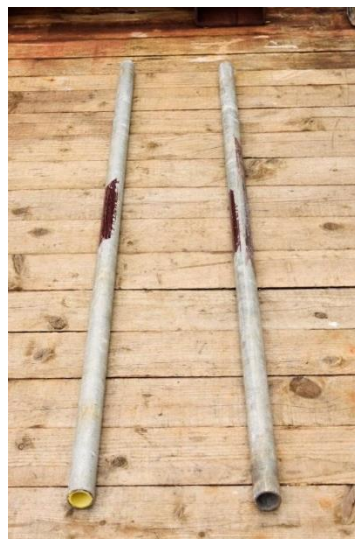
Second Event

The same vessel was engaged in similar backloading operations at a different installation. The Crane Op had backloaded a tote tank onto the vessel deck when he noticed something on top of the lift after landing. He decided to retrieve the lift for further investigation but as the tote tank was hoisted, the movement caused one of the pieces to fall onto the vessel deck. It was then decided to manoeuvre the sling into a safe position (away from the objects) to allow ship staff to investigate. The vessel deck crew identified two scaffolding poles approximately 1.9m in length and weighing 10kg each.
