Safety Alert

Number: 19-11

Subject: Whip Checks on Bulk Hoses

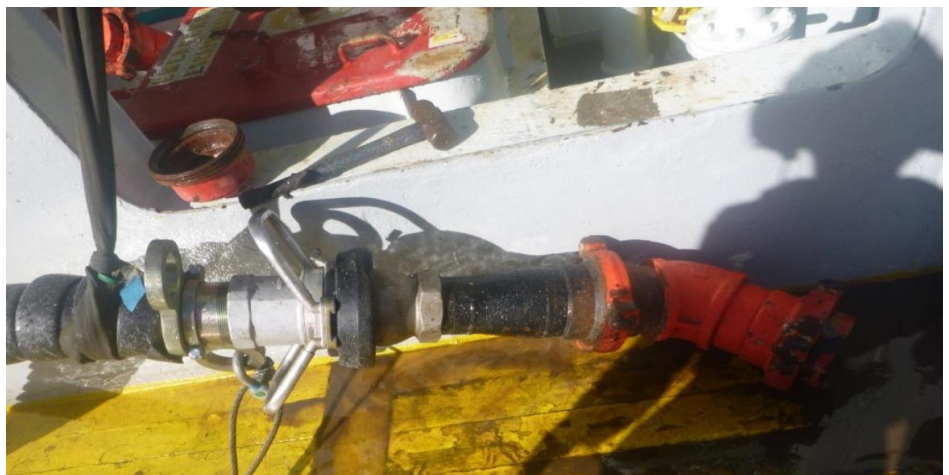
Incident 2: Several months later a different vessel was alongside an installation discharging product. For a totally unrelated reason again the bulk hose disconnected from the manifold however this time the hose was prevented from whipping back by the addition of a webbing strop 'whip check'. No injuries were sustained by any of the crew.

The hose end following disconnection. Note the 'whip check' in place.

Following on from the first incident the client immediately recognised the need to learn the lesson and prevent a similar incident occurring again. As a preventative measure they immediately implemented a blanket requirement for all their vessels undertaking bulk hose operations to install a 'whip check' strop (Soft sling or similar restraining strop which would not damage or choke the hose) between the hose and a strong point on the vessel to remove the potential for another bulk hose to disconnect violently and strike an AB who may be in the immediate area.

Implementing 'whip checks' on bulk transfer hoses was seen as a simple and effective way of preventing the hose violently 'whipping' away from a deck manifold should any of the connections in the system fail.
