# Safety Alert

**Number: 19-13**

**Subject: Launching Conditions for Fast Rescue Craft**

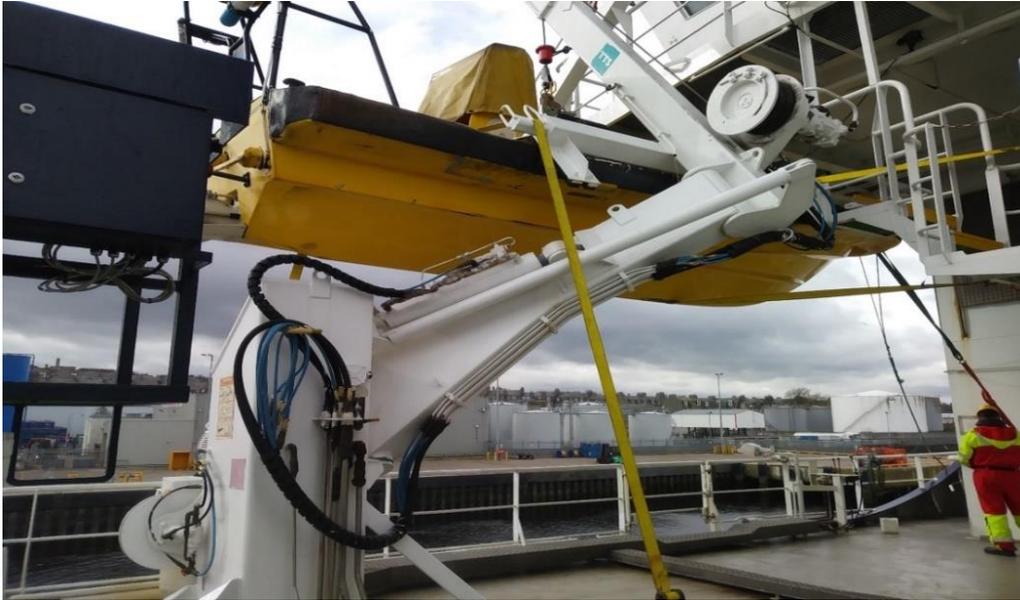
Upon investigation it was found that the arm on the emergency lowering valve which activates the winch sequence was stuck in the lowered position (see pictures on page 2). This meant that when the emergency lowering system was activated the system thought that the davit had already swung the FRC over the ship side and proceeded to immediately lower the FRC on to the deck and equipment below.

Arm stuck in position

- The site was safely secured, and a toolbox talk held to plan the recovery of the FRC. The FRC was then moved safely to the main deck using the vessel crane so that the equipment could be inspected thoroughly.
- The valve was overhauled and replaced and tested for full functionality.
- The procedure for testing the emergency lowering was amended to ensure that the valve is checked prior to activation.
- The planned maintenance system jobs were reviewed to ensure clarity, and everyone was reminded that if they have any queries regarding the full task description of jobs they are to ask for assistance.

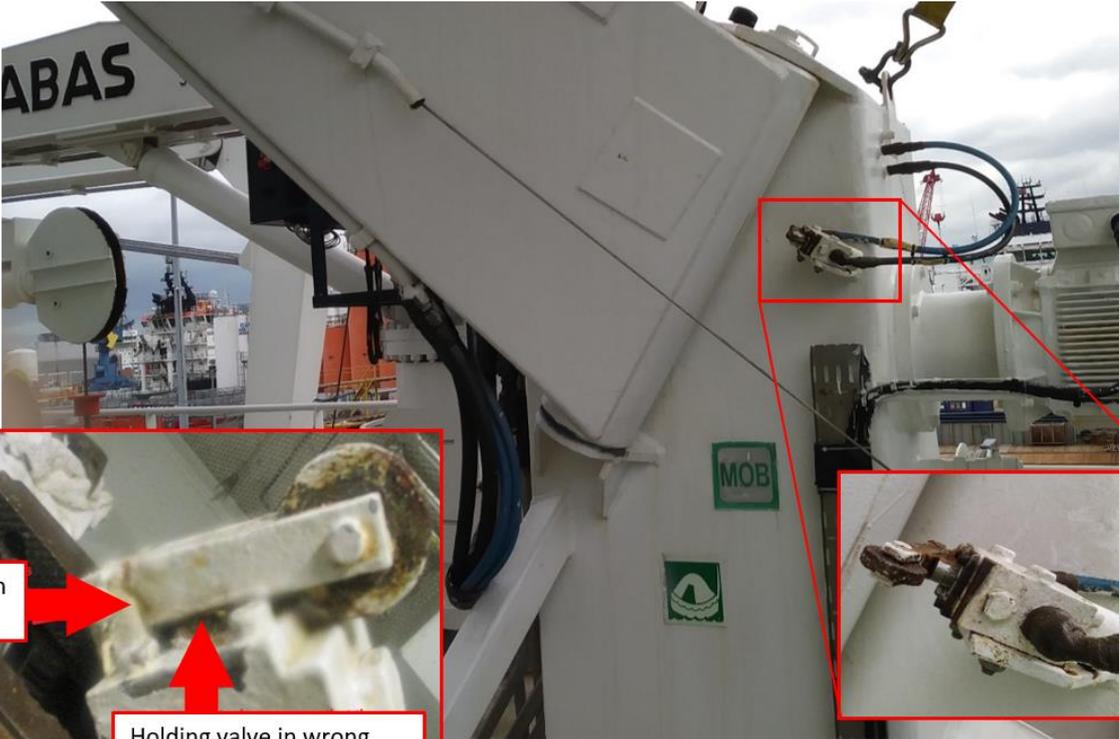
Holding valve in wrong position changing the lowering sequence
