Safety Alert

Number: 20-04

Subject: PDO - Nets v Tarpaulins for Covering Cargo Carrying Units

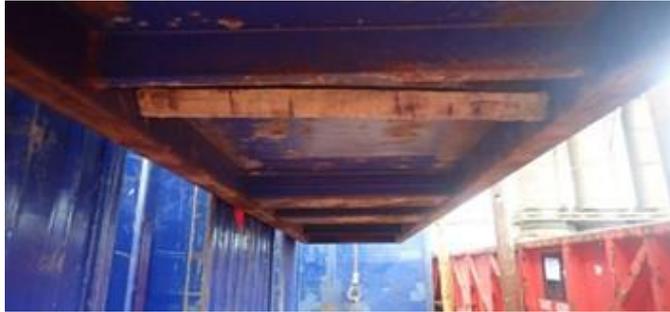
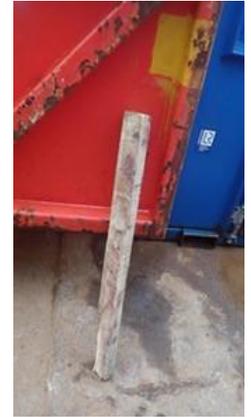
A cargo basket was being discharged from a Platform Supply Vessel to the installation when a Potential Dropped Object (PDO) was discovered jammed against the underside of the basket. The PDO was found to be a wooden baton of the type often used to support covers attached to open topped Cargo Carrying Unit's (CCU's).

- Wooden batons are normally used to support the tarpaulin cover used on open top CCU's
- Wooden batons are only held in place by being jammed against the sides of the open top
- There is generally no securing mechanism holding the wooden batons in place
- Batons need to be 'knocked out' prior to heavy cargo being lifted from the CCU by crane
- Knocking out batons from high sided CCU's can result in it falling onto those removing it

Tarpaulins and batons do have their uses when required for covering cargo, but their use should always be risk assessed and evaluated against other cover types which may be readily available.

- Type of cargo and the effects of its exposure to the environment
- The manual handling issues that may be encountered by the end user
- Consider the use of 'cord strap' or similar instead of wooden batons to support covers. (particularly on high sided open top units)

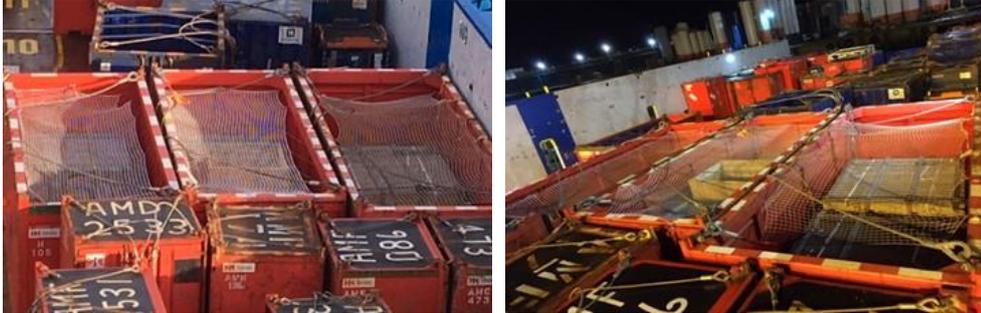
The above photo taken during the trial shows 3 x open top CCU's backloaded on the PSV's deck. Note that the lifting gear cannot fall inside the CCU's and snag on the cargo, yet wooden batons are not being used to support the net covers.

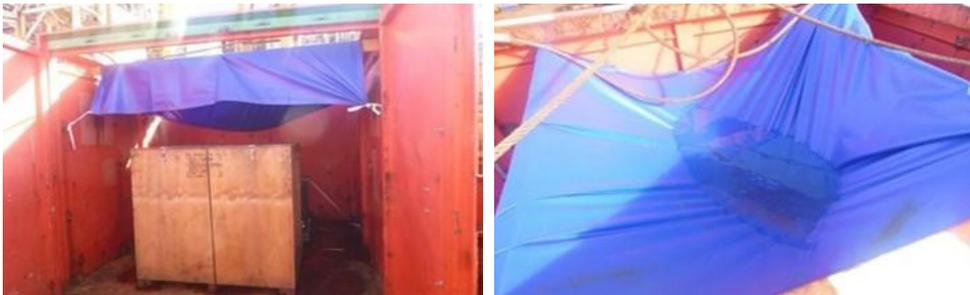
The above photo shows an open top CCU delivered offshore with a tarpaulin & baton cover.

- The tarpaulin was full of water (Extra weight)
- The tarpaulin couldn't be removed without soaking the wooden crate. (Detrimental)
- The wooden batons holding the tarpaulin up were only jammed in place
- There was a risk of the wooden batons falling out under the extra weight of water (PDO)

Would it have been safer and more beneficial to wrap the crate in tarpaulin and place a net across the top of the unit?
