Safety Alert

Number: 21-06

Subject: Dropped Object Awareness

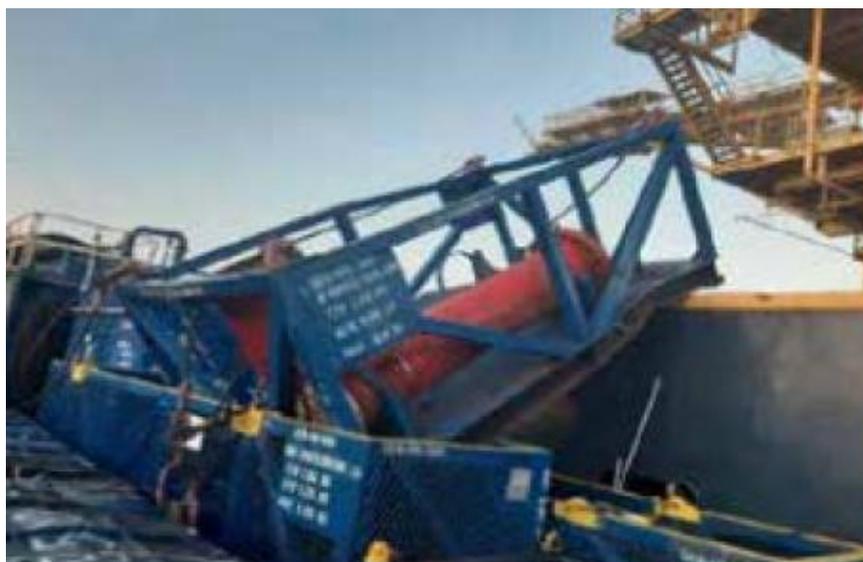
Photographs / Supporting Information

Dropped Objects are a persistent problem within our industry. In recent weeks, one of our member's fleets across all regions has incurred a rise in incidents during cargo operations relating to Dropped objects or Potential Dropped Objects. Such incidents and near misses include: Container doors not secured, Bulk Hose falling from its stored position, Equipment not secured within units, Potential dropped objects found on the lifts and a vessel even had an incident where a cargo unit of 7.5t fell from a significant height onto the deck (see picture below).

- Remain vigilant and attentive to the cargo operation. If you see something is wrong – Use your Stop Work Authority!
- Do not approach the lift until it is landed on the deck and the crane driver has given the signal to approach.
- Do not stand under a lift. Keep well clear. Always wear appropriate PPE and remember PPE is the last line of defense; it should not be the only line of defense!
- All dropped or potential dropped objects to be reported to the installation/rig as soon as identified as well as the company and client at the first opportunity.
- Dropped Objects and Potential Dropped Objects' take various forms, not just tools. Consider loose dirt/gravel, valve caps or grid walkways not secured etc., The lifts themselves are potential dropped objects - always remain vigilant when approaching a lift.
