# Safety Alert

**Number: 22-01**

**Subject: High Levels of H<sub>2</sub>S Detected in Bilge Tank**

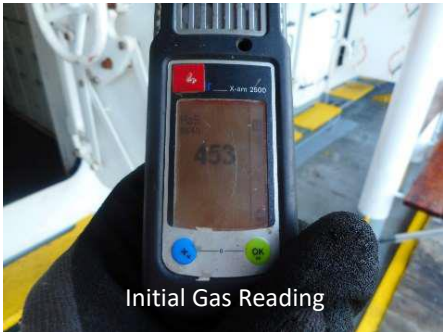
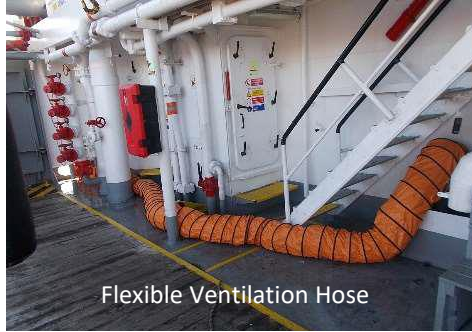
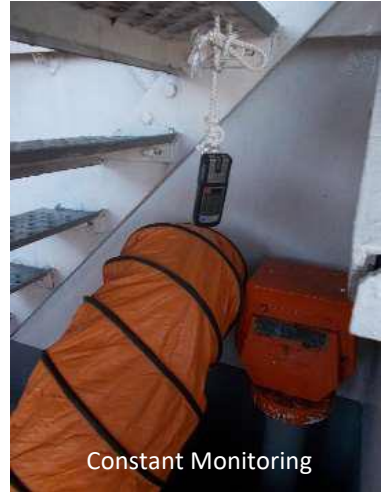
## Photographs / Supporting Information

On a member's vessels during routine transfer of bilge water from the engine room bilge wells to bilge water tank, the crew observed a smell of "rotten eggs" from the bilge tank vent. The transfer was immediately stopped. During measurements at the tank vent pipe with a multi gas meter, a level of 453ppm of H<sub>2</sub>S (Hydrogen Sulphide) was detected.

- Bilge tank was not disposed for a long period due to not reaching capacity
- Unable to inspect the tank on a regular basis
- Several tank corners solid residue which is very difficult to remove

- Transfer stopped (Stop the Job) and H<sub>2</sub>S concentration measured at the tank vent
- Emergency response team and client informed
- Flexible hose connected to the tank vent to ensure gasses guided away from the accommodation
- Assistance requested from local agencies on removal of the bilge residue and tank cleaning
- Constant monitoring of H<sub>2</sub>S levels by approved measuring device and crew in full respiratory protection
- Removal of bilge water, cleaning of the tank by specialised contractor and Gas Free certificate issued

- Regular checking of bilge water handling and arrangement for disposal
- Bilge water disposal to be combined with sludge disposal on a regular basis
- Review of vessels machinery cleaning practices
- Make H<sub>2</sub>S awareness part of the onboard training programme
