# Safety Alert

**Number: 26-13**

**Subject: Dropped Object – Loose Pipe Fell from Upper Level**

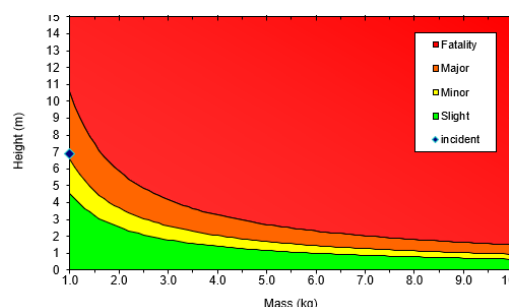
An investigation determined that the pipe most likely fell from a box containing metal offcuts located approximately 7 metres above the tank top. The pipe measured 1.14 metres in length and weighed approximately 1 kg with the potential outcome shown on the Drops Calculator below.

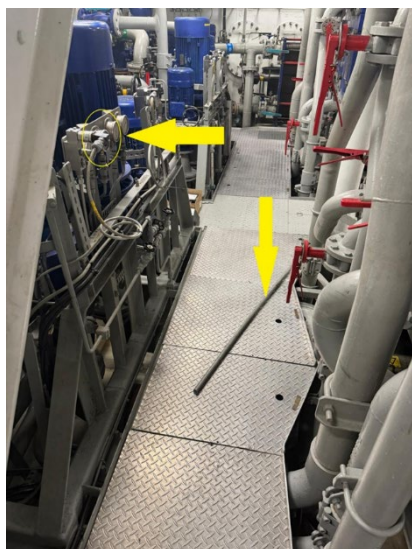
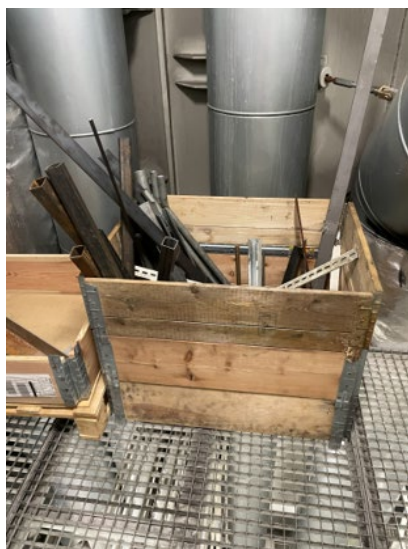
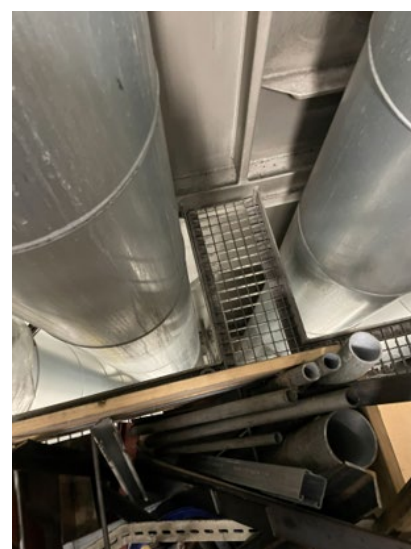
## Photographs / Supporting Information

During a routine inspection of a vessels engine room, a loose pipe was discovered on the tank top walkway.

The investigation determined that the pipe first impacted the area outside the walkway before bouncing onto the walkway, where it was later discovered.

The conclusion that the pipe fell from above is supported by damage observed on a sensor located near where the pipe was found.

- The vessel has removed the offcut box from the location. Improvements in the storage and management of off cuts have now been implemented.
- The vessel has conducted a hazard hunt for similar storage arrangements posing a hazard of objects dropped over a significant distance.
- All other vessels in the owners fleet have received instruction to conduct a similar hazard hunt to identify storage arrangements where there are hazards of objects dropped over significant distance, and if such hazards are identified to mitigate immediately, i.e. to re-locate the storage and to ensure integrity of storage arrangements acknowledging that objects falling out of a box does not only pose the risk of being hit by a dropped object, but also risks for slips, trips and falls.
