Marine Safety Forum – Safety Flash 08-17

Issued: 15th April 2008

Subject: Fatal Accident to a Crew Member During Mooring Operations

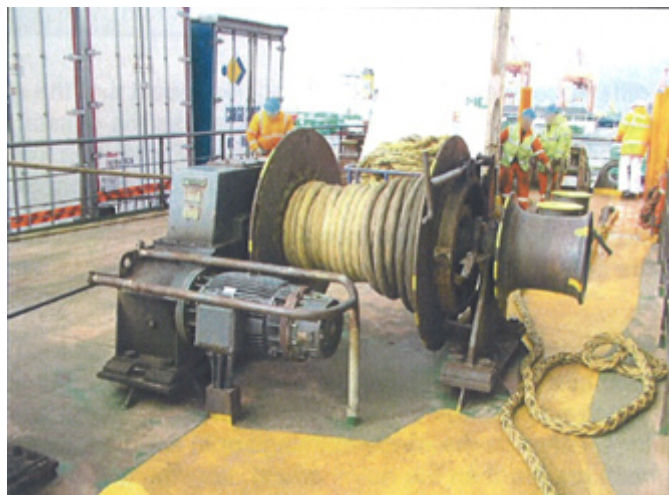
The stern line was made up of a polypropylene length from the ship which connected to a High Modulus Polyethylene (HMPE) line permanently secured ashore. The difference in elasticity of the two lines meant that the shorter, more elastic, polypropylene length was subject to material fatigue effects from the constant cycle of stretching and release. It was further degraded by exposure to ultraviolet (UV) radiation from sunlight. Subsequent tests revealed its breaking load to have reduced from 60 to some 35 tonnes.

The electric mooring winch used for the stern line had a stated nominal load of 12.7 tonnes and it was not immediately clear how this could have parted the rope, even in its degraded state. However, tests showed that the winch was capable of pulling up to 37 tonnes for a short period on first starting. There were no indications, either on the winch markings or in the manufacturer's manual, that the starting load was so much greater than the running load, nor was there any reference to the Minimum Breaking Load (MBL) of the rope to be used on the winch.

- Man-made fibre mooring ropes deteriorate in service and can have serious consequences if they part. Operators should develop a *Rope Management System* to provide a formal inspection routine of all mooring lines and include as a minimum:

- ❖ Assigning competent people with adequate training and experience to assess the condition of ropes.
 - ❖ A process of permanently identifying each rope, describing its function, specification and linking it to its warranty certificate.

- ❖ Keeping records of planned inspections of each rope, including: date of manufacture and putting into service; condition; exposure to sunlight (or other contaminants) and any unusual loads to which it has been subjected, etc.

- ❖ Establishing objective criteria for rope replacement and a specification for new ropes.
 - ❖ A storage routine in which all ropes are protected from damage and kept away from potential contaminants.

- Ensure that the full capabilities of mooring winches are known and understood by all those involved in conducting and managing mooring operations, including the Minimum Breaking Load of ropes to be used.
