# Safety Alert

**Number: 21-08**  
**Subject: Potential Dropped Object**

**Published: 27/04/2021**

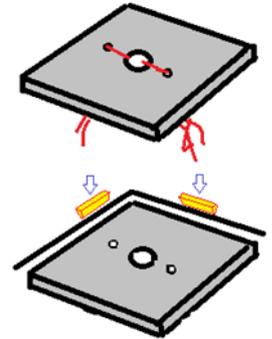
After discharge to an installation, a metal plate (see attached photos) size 250 x 170 x 55mm weight **1.6kg** was found inside a forklift pocket hole by the platforms deck foreman on a 10' container when landed on the platform from the vessel.

One of the possible reasons that this particular plate may have been washed from its position within the main deck could have been that it was quite badly “bent” as can be see in pictures below. This could have enabled water breaking onto the vessel’s main deck, to work beneath the plate to lift it.

It is recommended that vessels check their pin post/lifting point plates, to ensure:

- they are not buckled
- that they fit correctly
- there is an ability to secure them with seizing wire and that it is done. If the plates do not have holes, to enable fixing with seizing wire, then they should be modified.

If there is no securing point beneath the plates, then small wedges could be used to assist in making sure the plates fit snugly.
