MARINE
Safety Forum

All Members Meeting 16th November
Beach Ballroom, Aberdeen

Regulations and Resolutions

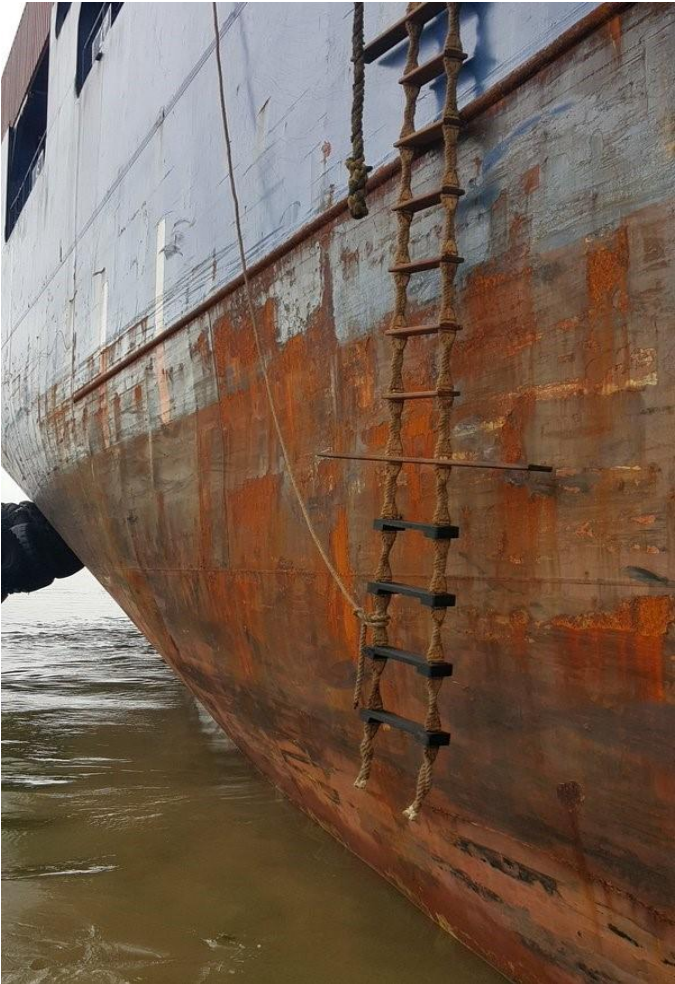
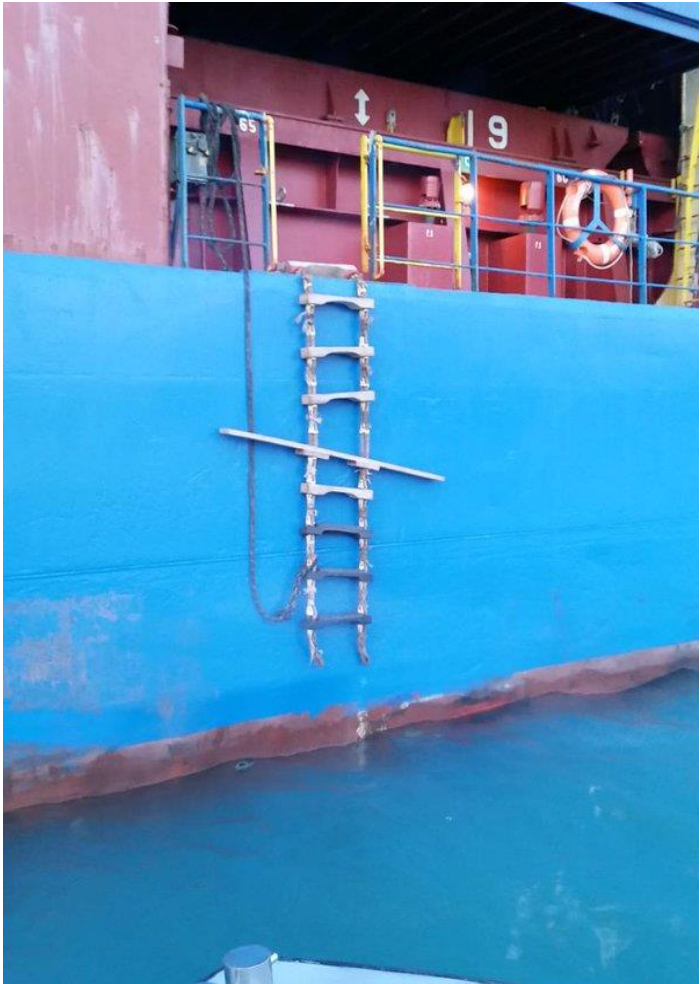
Retrieval Lines

- 2.1.5 When a retrieval line is considered necessary to ensure the safe rigging of a pilot ladder, the line should be fastened at or above the last spreader step and should lead forward. The retrieval line should not hinder the pilot nor obstruct the safe approach of the pilot boat.

Retrievol lines (sometimes called 'kicking lines') are often used to lift the pilot ladder. These lines are potentially dangerous, they may lead the pilot astray or be a hazard to the pilot's feet.

When a retrieval line is used to assist in the lifting of a pilot ladder, it should be secured so above the first spreader bar and should not be used. The retrieval line should not be used for the approach of the pilot boat.

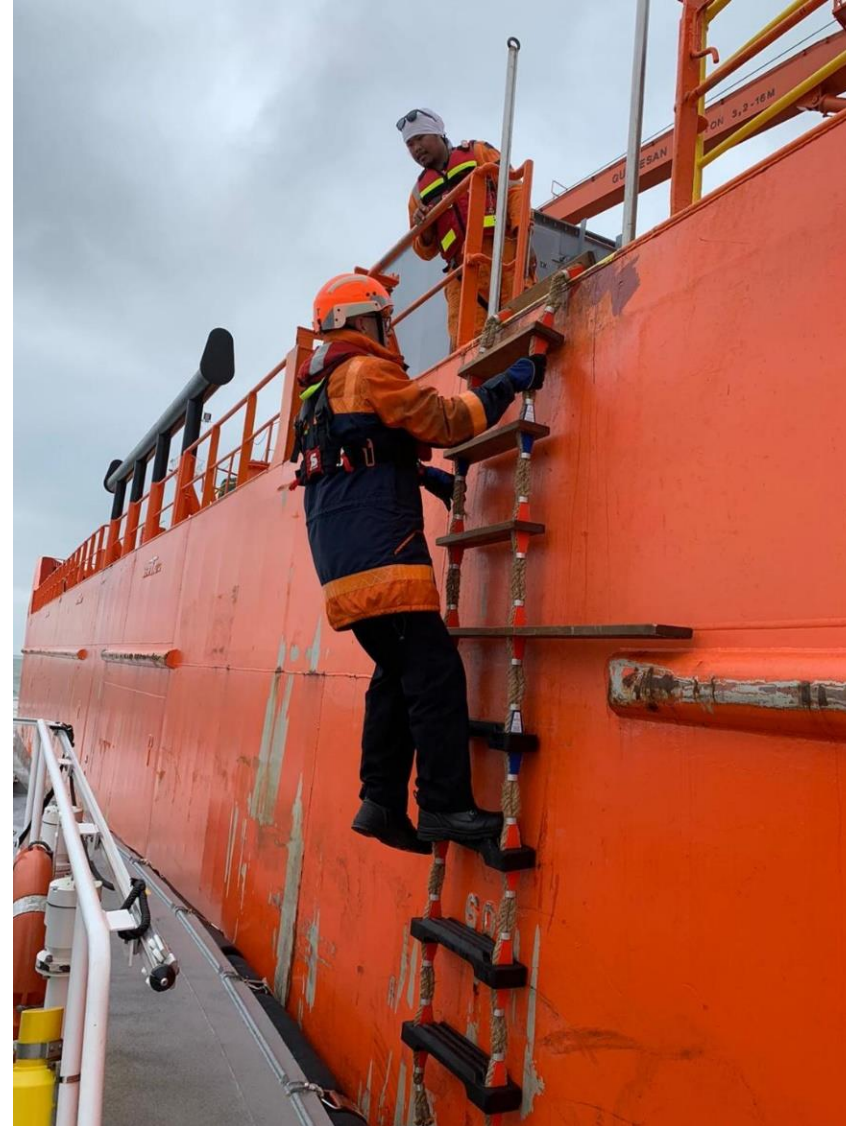
Compliant stanchions ?

Adequate handholds should be provided at the point of embarking or disembarking from the ship on each side which should be not less than 0.7m or more than 0.8m apart. Each handhold should be rigidly secured to the ship's structure at or near its base and also at a higher point, not less than 32 mm in diameter and extend not less than 1.2 m above the top of the bulwarks.

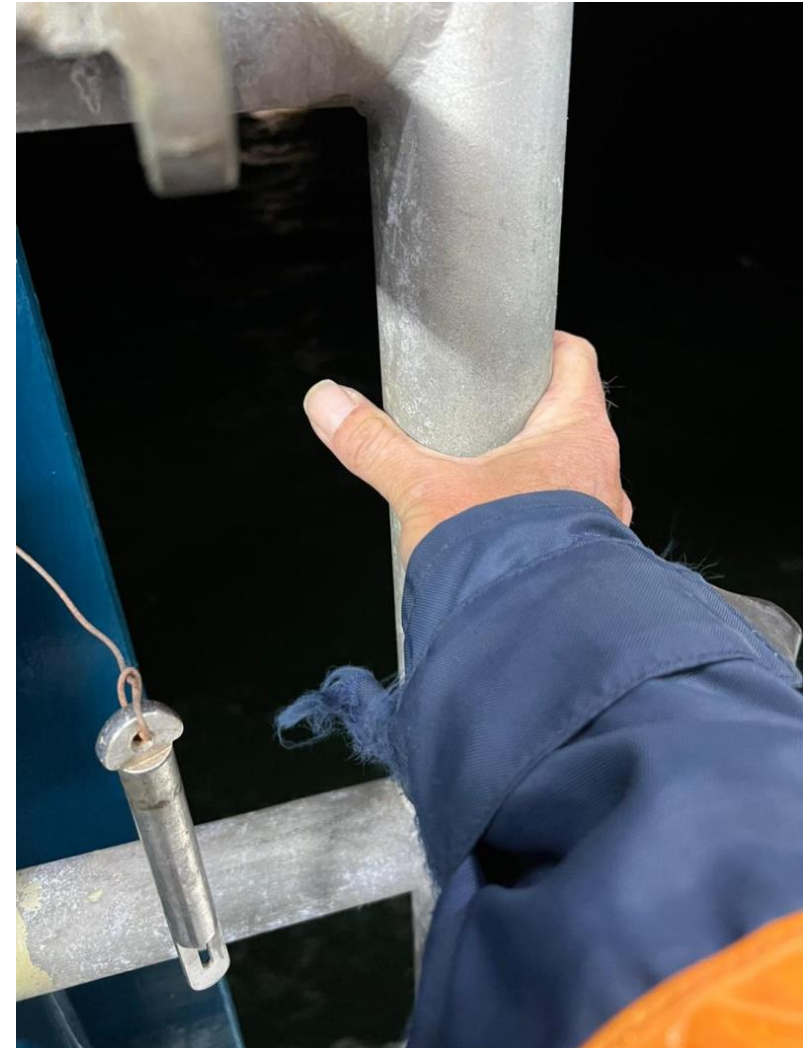
Grip

Currently recommendation is for diameter not less than 32 mm, it is suggested that the maximum diameter should be not more than 36 mm.

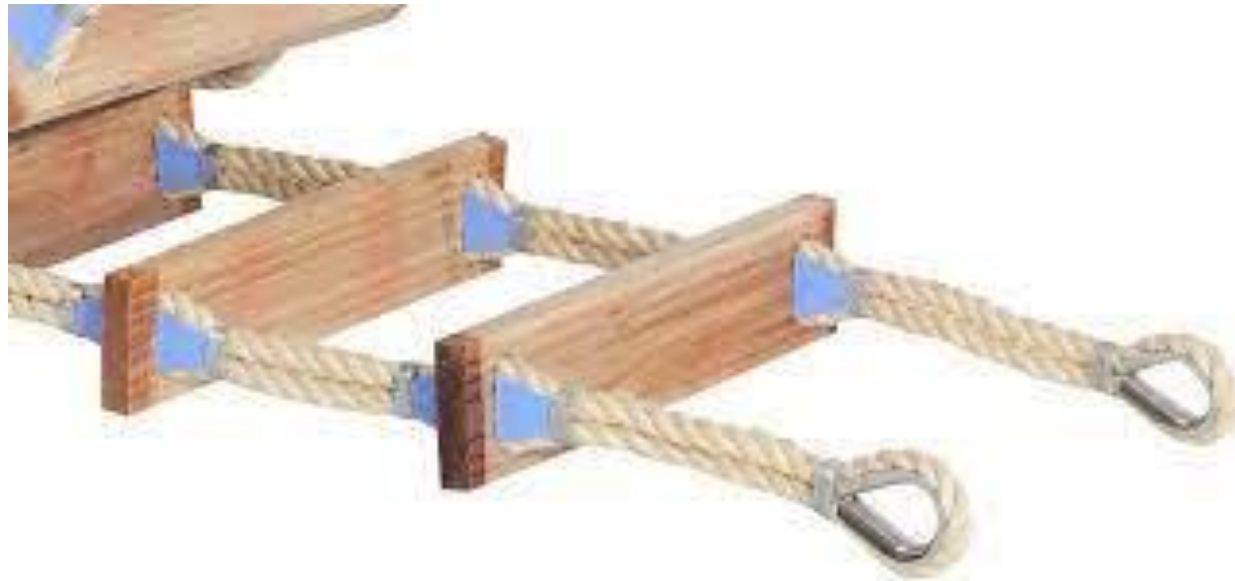
Securing

- IMO Resolution A 1045
- 2.2.1 The securing points, shackles and securing ropes should be at least as strong as the side ropes specified in section 2.2 below
- 2.2 The side ropes of the pilot ladder should consist of two uncovered ropes not less than 18 mm in diameter on each side and should be continuous, with no joints and have a breaking strength of at least 24 Kilo Newtons per side rope

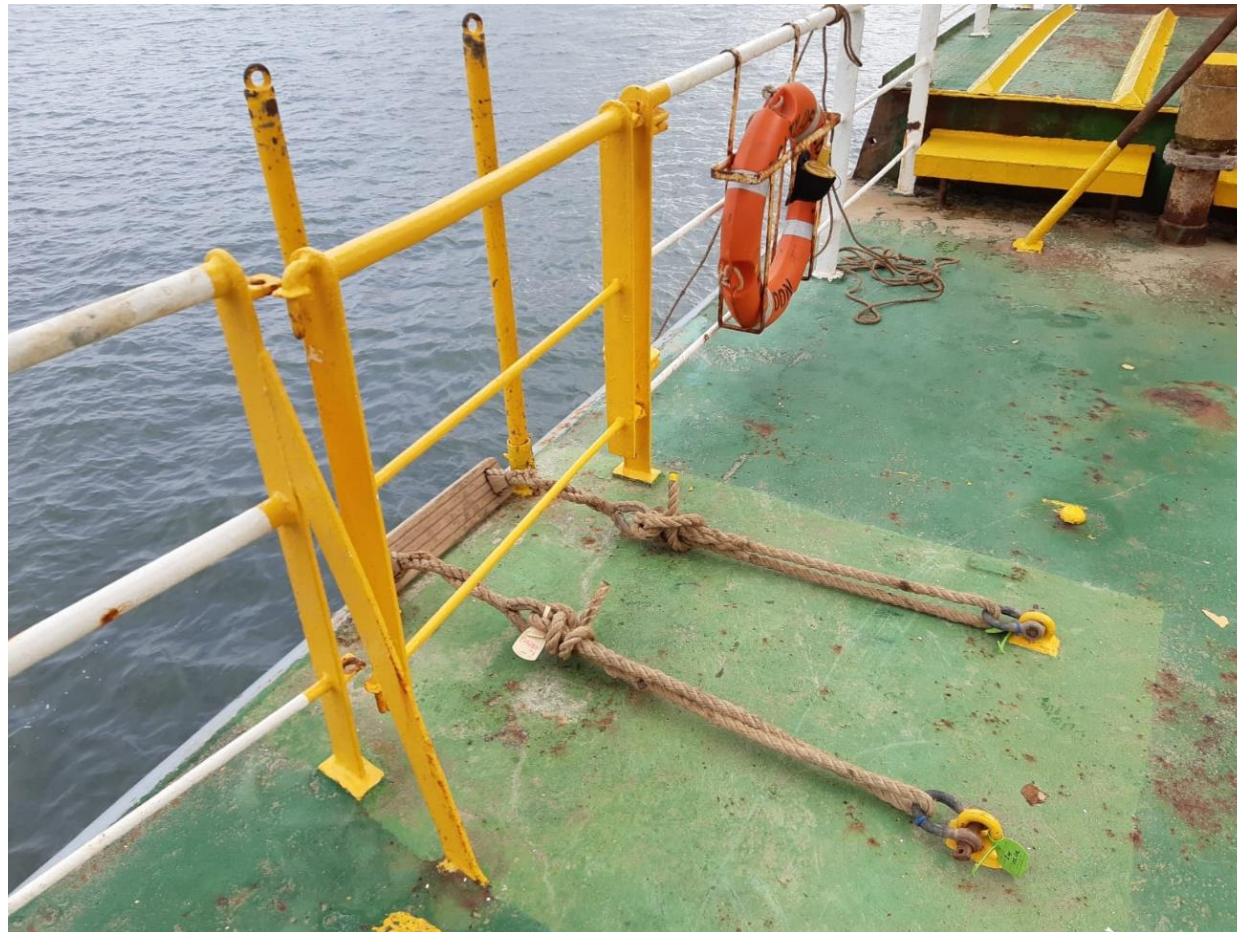
Securing at Intermediate Lengths

Where the pilot ladder is deployed at less than its full extent, alternative means of securing it in position must be employed.
