Marine Safety Forum – Safety Flash 08-24

Subject: Catastrophic Failure of Vessel Main Crane Winch

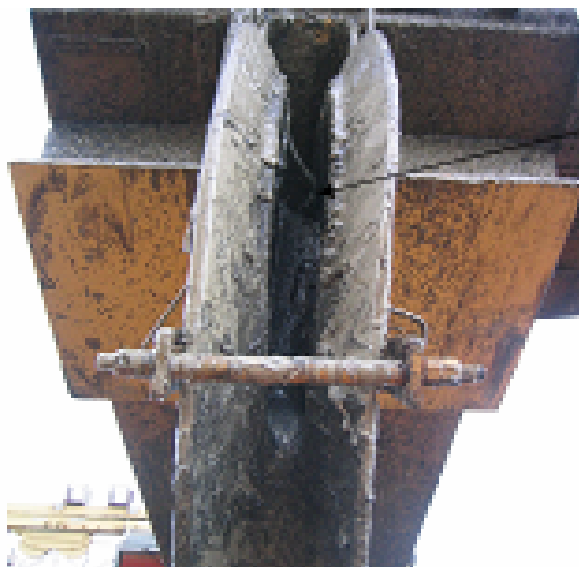
Immediate investigation identified the failure point of the wire rope to have been at the second sheave of the knuckle boom.

Subsequent inspection of the sheave has identified significant damage that would be consistent with the sheave failing to rotate during the operation of the crane. The resultant wear on the wire rope is potentially the cause of the rope failing.

Photograph shows the wear in the crane sheave that has potentially caused the wire rope to fail.

The crane was operating with the heave compensation engaged at the time of the failure.

- All vessels that are operating cranes of the same model or similar should carry out as soon as possible an inspection of crane sheaves to identify any signs of wear that would indicate a potential failure of the sheaves to operate as designed. This inspection should be carried out by the vessel Chief Engineer or other competent person.
- These checks should be daily until the cause of the failure has been established by the crane manufacturer. Any defect found should be reported to the crane manufacturers.
- All vessels with cranes that regularly operate Subsea should check sheave integrity and visibly check rotation of all sheaves and should be aware of how quickly a failure of this nature could occur particularly when operating with heave compensated systems.
