Safety Alert

Number: 16-04

Subject: Potential Dropped Object – Inbound Cargo

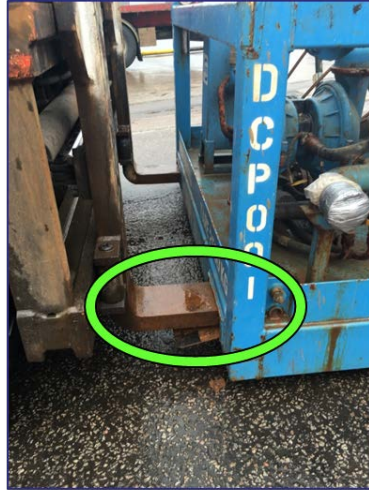
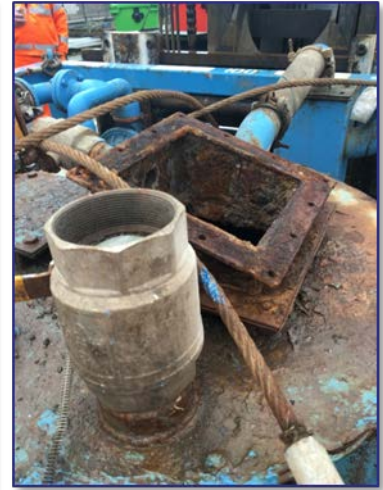
The Dust Pump was back-loaded at a Semi-Sub drilling rig. Once on the quayside it was discovered that a steel blanking plate had been stored in the fork-lift pocket whilst the unit was in service.

This plate had potential for serious harm if dropped.

Estimated Weight of Steel Plate Potential Dropped Object was 2kg. From the DROP's calculator this could be fatal when falling from heights of 6.5 metres and above.

The unit was inspected offshore but the plate was not noticed. The units' stowed position had made it very difficult for the crew to examine in detail.

Offshore crews reminded to carry out thorough checks of all cargo prior to back-loading to vessels.

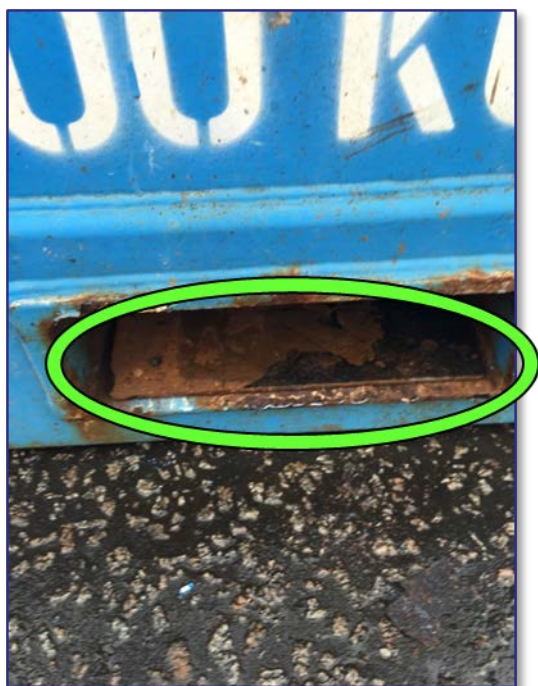
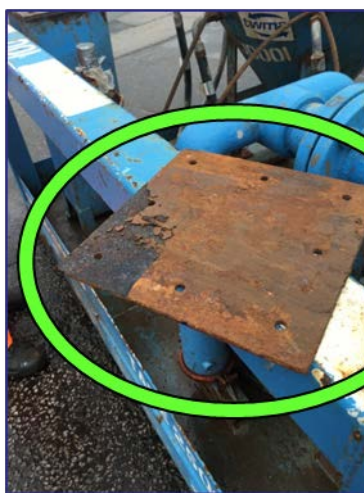
Sometimes things are not always what they seem.....
