Safety Alert

Number: 17-05

Subject: Unsafe Mooring Practices

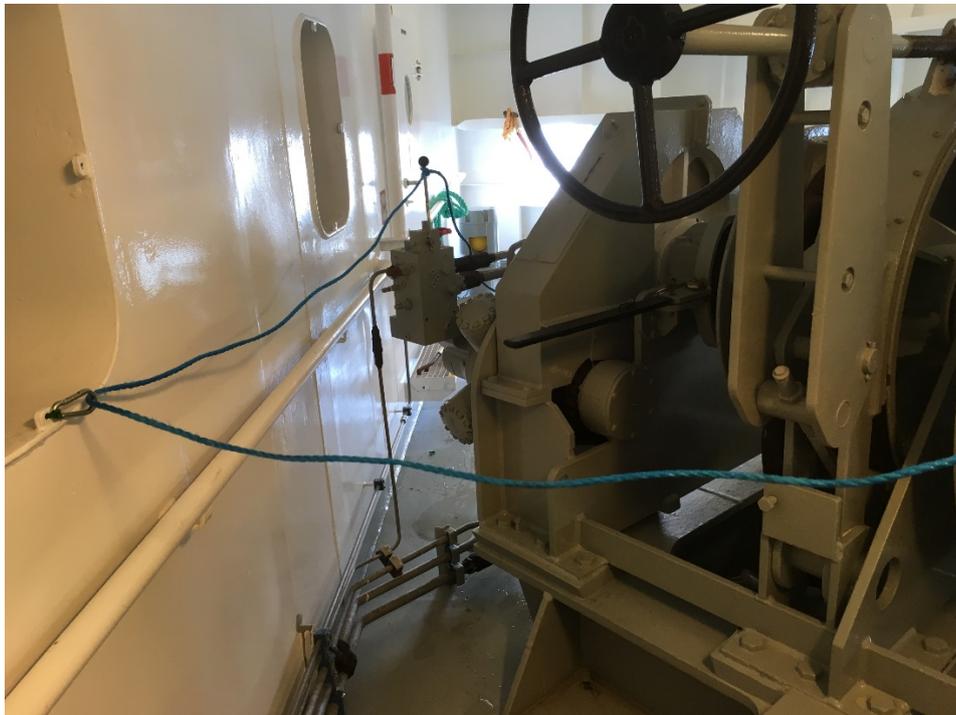
During a routine marine inspection of two sister vessels it was observed that rope lines had been attached to the mooring winch control levers to facilitate 'remote' operation of the winches.

There are numerous dangers associated with this practice including:

- Accidentally pulling on the wrong line and performing an unintended action
- Crew member getting entangled in the lines and inadvertently operating the winch
- Lack of proper control of winches

The dangers associated with this practice were immediately highlighted to the vessels crews and the lines removed.

The vessel owner is investigating the reasons for this modification and will act accordingly.

Don't compromise and complicate the operation by introducing additional risks.
