Marine Safety Forum – Safety Flash 15-02

Issued: 13th January 2015

Subject: Dropped Object

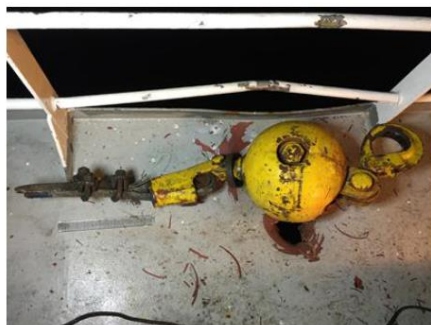
One of our vessels has reported a dropped object incident while working deck cargo at a rig. The rig had a dual line crane (single whip, double block) and was using the double block at the time of the incident while discharging cargo from the vessel. As the crane commenced lowering the double block down towards the vessels' deck, the single whip line headache ball and hook assembly detached from the crane and landed on the top of the safe haven damaging the deck. Fortunately the deck crew were standing clear and were approximately 4m from the point of impact. Although shaken, there were no physical injuries.

The assembly weighed **160kg** and fell approximately **50 meters** giving an impact force of **784KN** this would most certainly have resulted in a fatality if it had struck a crew member.

Headache ball and hook assembly
on deck after impact.

Note penetration in deck and
distortion of steelwork

- Be aware and warn all crew of the potential for dropped objects during cargo operations
- Stand clear of the load route - No loads should ever be lifted over people
- Maintain visual contact of the load at all times
- Check every load to ensure nothing is loose or damaged before dispatch
- Make sure that all loads are properly secured
- Housekeeping procedures should be followed to minimise the risk of equipment being left on loads
- Ensure that all cargo is prepared in accordance with the industry best practice
- Report all Incidents of dropped objects to the OIM.
- Stand Clear from moving Crane boom and/or block **even with no load**, do not approach the crane slings/hook until the crane is full stop and ensure all safe and secure prior to approaching.

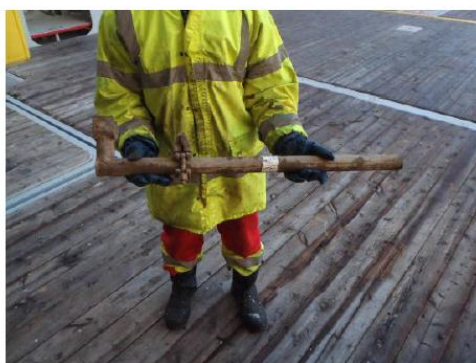
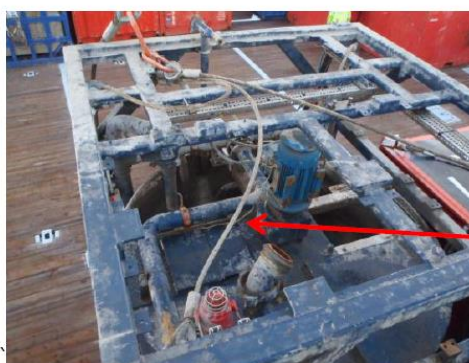
Another vessel has reported a potential dropped object which was spotted after back loading from a rig.

Loose Object
found here
