# Safety Alert

**Number: 21-05**

**Subject: Wearing and Stowage of PPE**

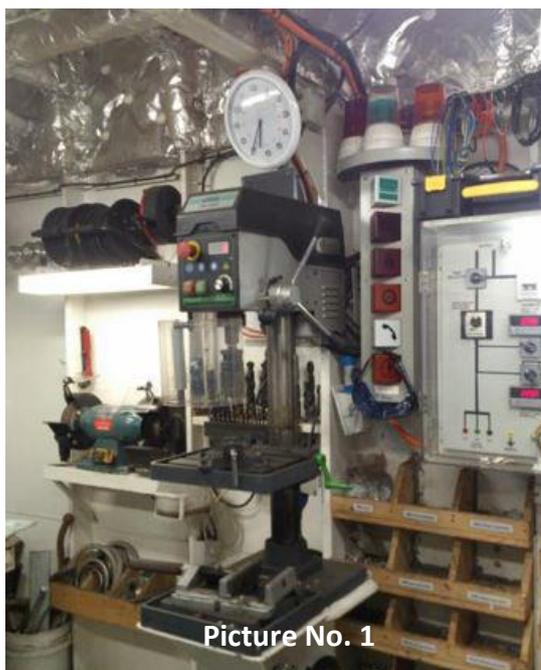
In the picture No 1 it can be clearly seen that goggles were being stowed in an unsuitable position next to drilling and cutting machinery within the workshop, where there was a very good chance that particles could land within the protective gear, and therefore could fall into an operator's eyes. In picture No 2 the new safe stowage is shown.

This incident shows the importance of using the correct eye protection and its correct stowage. On this particular vessel, since this incident, the stowage of all eye protection PPE, has been re-located and enhanced by placing it in clear plastic bags to ensure it is clean and free from foreign objects before being used.

1. The stowage for eye protection has been changed to a safer position, and within clear plastic bags.
2. The Risk Assessments for use of Power Tools, Hot Work and Grinding have been adjusted to state that "Goggles MUST be worn" as opposed to "Correct PPE should be used."
