Safety Alert

Number: 22-03

Subject: Whip Checks on Bulk Hoses - Update

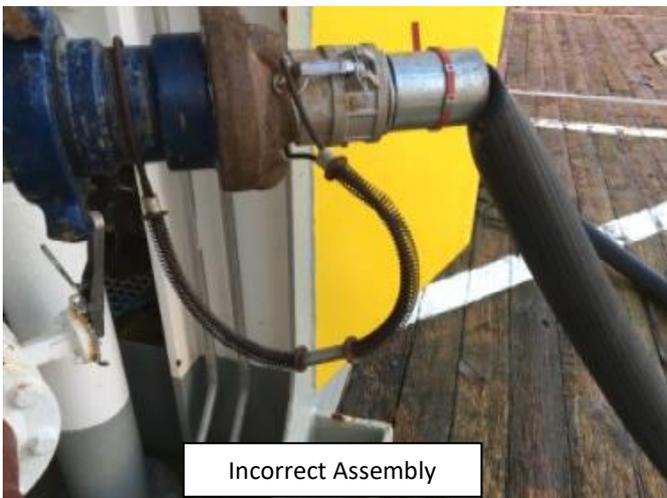
During a routine deck inspection on a member’s vessel, it was noted that a whip check was not fitted correctly. The below photo shows the whip check as it was found attached to the hose:

Note that the whip check does not incorporate all the connections. If the cam-lock were to part under pressure the whip check would not prevent the hose whipping back.

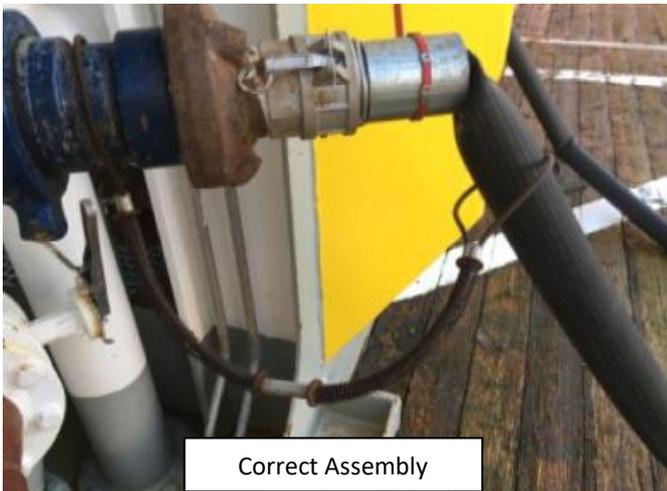
The whip check must encompass all connection components to allow it to operate as per design intent.
