# Safety Alert

**Number: 23-12**

**Subject: Near Miss during Garbage Compactor Backload**

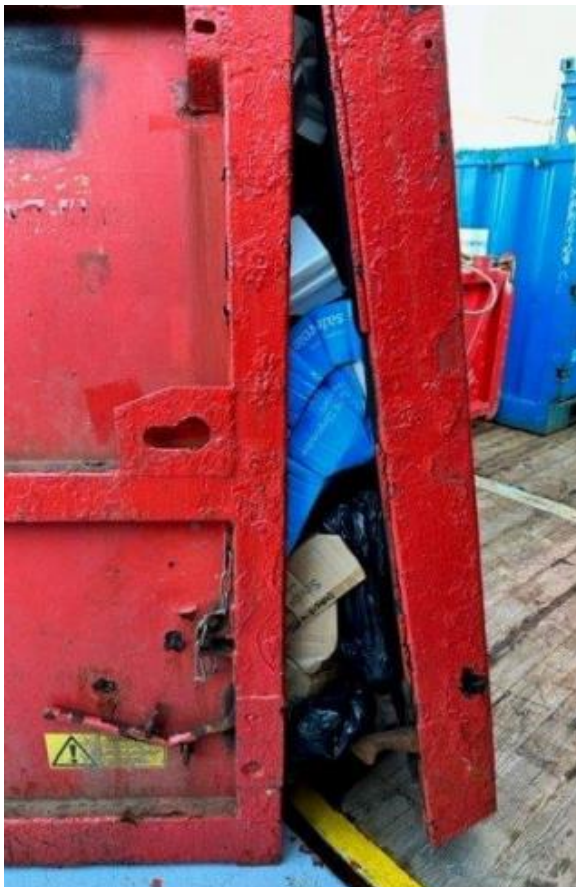
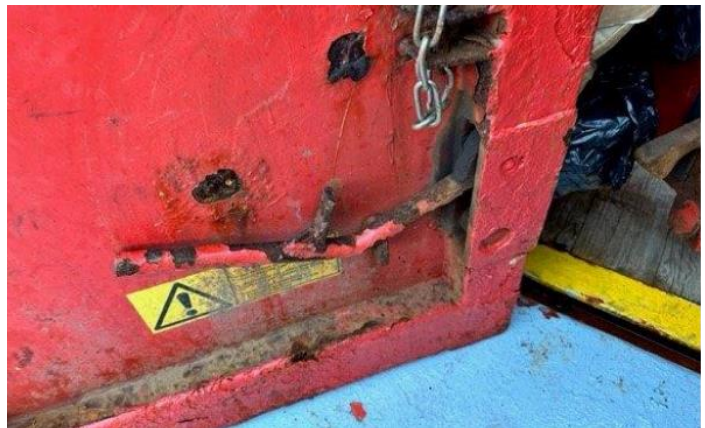
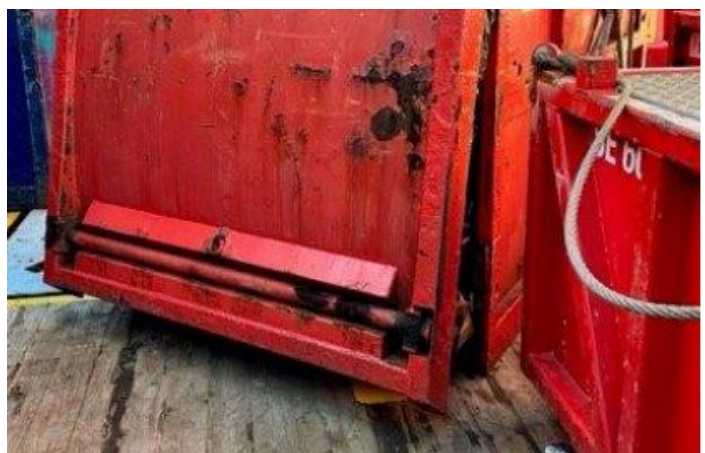
## Photographs / Supporting Information

During cargo operations at an offshore installation a waste garbage compactor unit was being lowered to the deck of a Platform Supply Vessel (PSV). During the lifting operation the door opened slightly, resulting in a small quantity of garbage being spilled onto the deck of the PSV. Fortunately, the compactor was at deck level when the door opened. No injury or environmental impact occurred.

The vessel deck crew noted on review of the compactor that the securing pin appeared to be damaged / in poor condition.

The crew on the installation were briefed on the need to inspect the securing arrangement on each unit prior to lifting. The unit was taken out of service and the logistics base requested to review the inspection regime of the units supplied.
