# Safety Alert

**Number: 24-01**

**Subject: Hand Injury After Tubular Cargo Shifted**

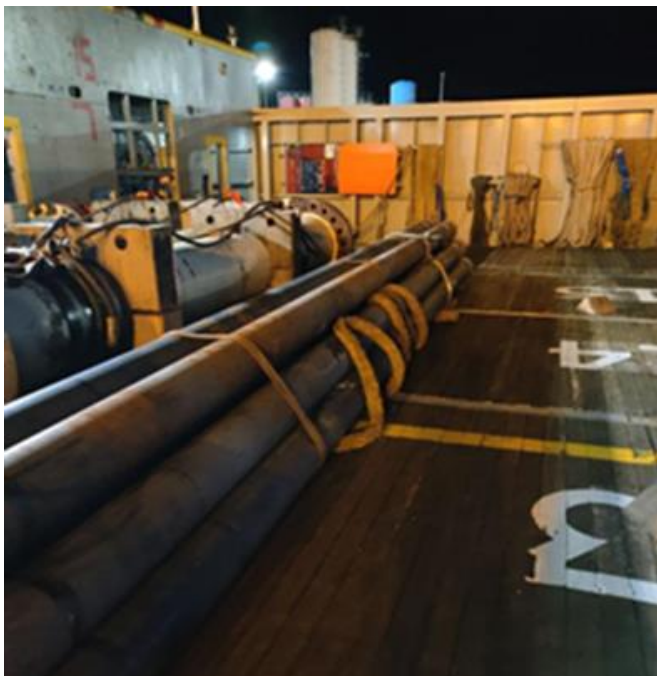
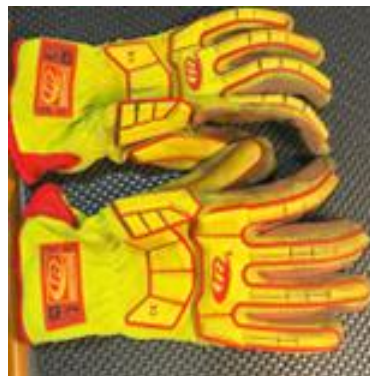
## Photographs / Supporting Information

During a deck cargo operation in port, the duty AB adjusted a bedding rope to clear the deck for the next lift. As he tried to stow the rope one of the upper pipes slid down and trapped his right hand. The IP couldn't manage to free his hand by himself. Stevedores immediately assisted by asking the crane to raise the lift. The AB was in full PPE and was wearing impact gloves.

The IP did not anticipate the movement of the tubulars as they settled and put his hand in the line of fire unnecessarily.

Settling of tubular cargo is a known hazard within the industry.

A safety flash was issued to the vessel owners fleet to notify them of the incident, followed up by information on the "Movement of Bundled Tubulars" and "Deck Pipe pins".
