# Safety Alert

**Number: 26-17**

**Subject: Scaffolding Unit Collapse – Hi Potential Incident**

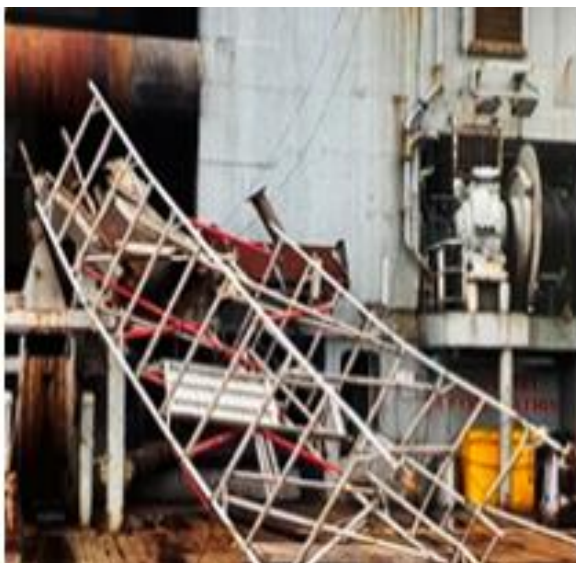
## Photographs / Supporting Information

A three-tier mobile scaffolding unit was being repositioned near the provisions crane pedestal by the Bosun and an AB. Due to seized wheels; the scaffold was moved by dragging rather than rolling. When the scaffold reached a raised metal plate near a skylight, the unit was lifted to continue movement.

During this activity, the scaffold became unstable and collapsed, falling three deck levels to the main deck. At the time of the collapse, no exclusion or drop zone had been established on the lower deck. No personnel were present below and no injuries were sustained.

- The mobile scaffolding unit was not confirmed fit for movement.
- The scope and risk of moving a multi-tier scaffold were underestimated, increasing instability and consequence.
- Task planning and the reassessment of changes were insufficient.
- Risk controls were not effectively implemented, including personnel exclusion from potential drop zones.
- Stop Work Obligation was not applied when risk increased.

- Scaffold must be fit for use before handling or movement – Seized wheels, ineffective brakes, and unsecured locking pins significantly increase instability risk.
- Scaffold height and design must match onboard capability – Multi-tier scaffolds introduce higher risk and require appropriate competency, planning, and visible supervisory oversight.
- Risk assessments must result in effective work controls – Identified hazards require active implementation and verification, including exclusion/drop zones and line-of-fire management.
- Stop Work Obligation must be applied when risk increases – Tasks should be paused when conditions change, difficulty is encountered, or additional planning or resources are required.
